THE STREAM

NEWSLETTER FROM
CASHMERE STREAM CARE GROUP (CSCG)
AUGUST 2018

SPECIAL EDITION Too much brown, not enough blue

Cashmere Stream water clarity results

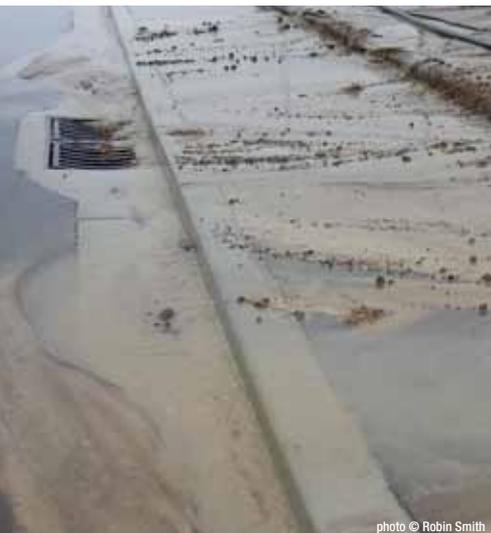
One example of how fine sediment gets into Cashmere Stream – sediment runoff from a development swamping sediment control measures

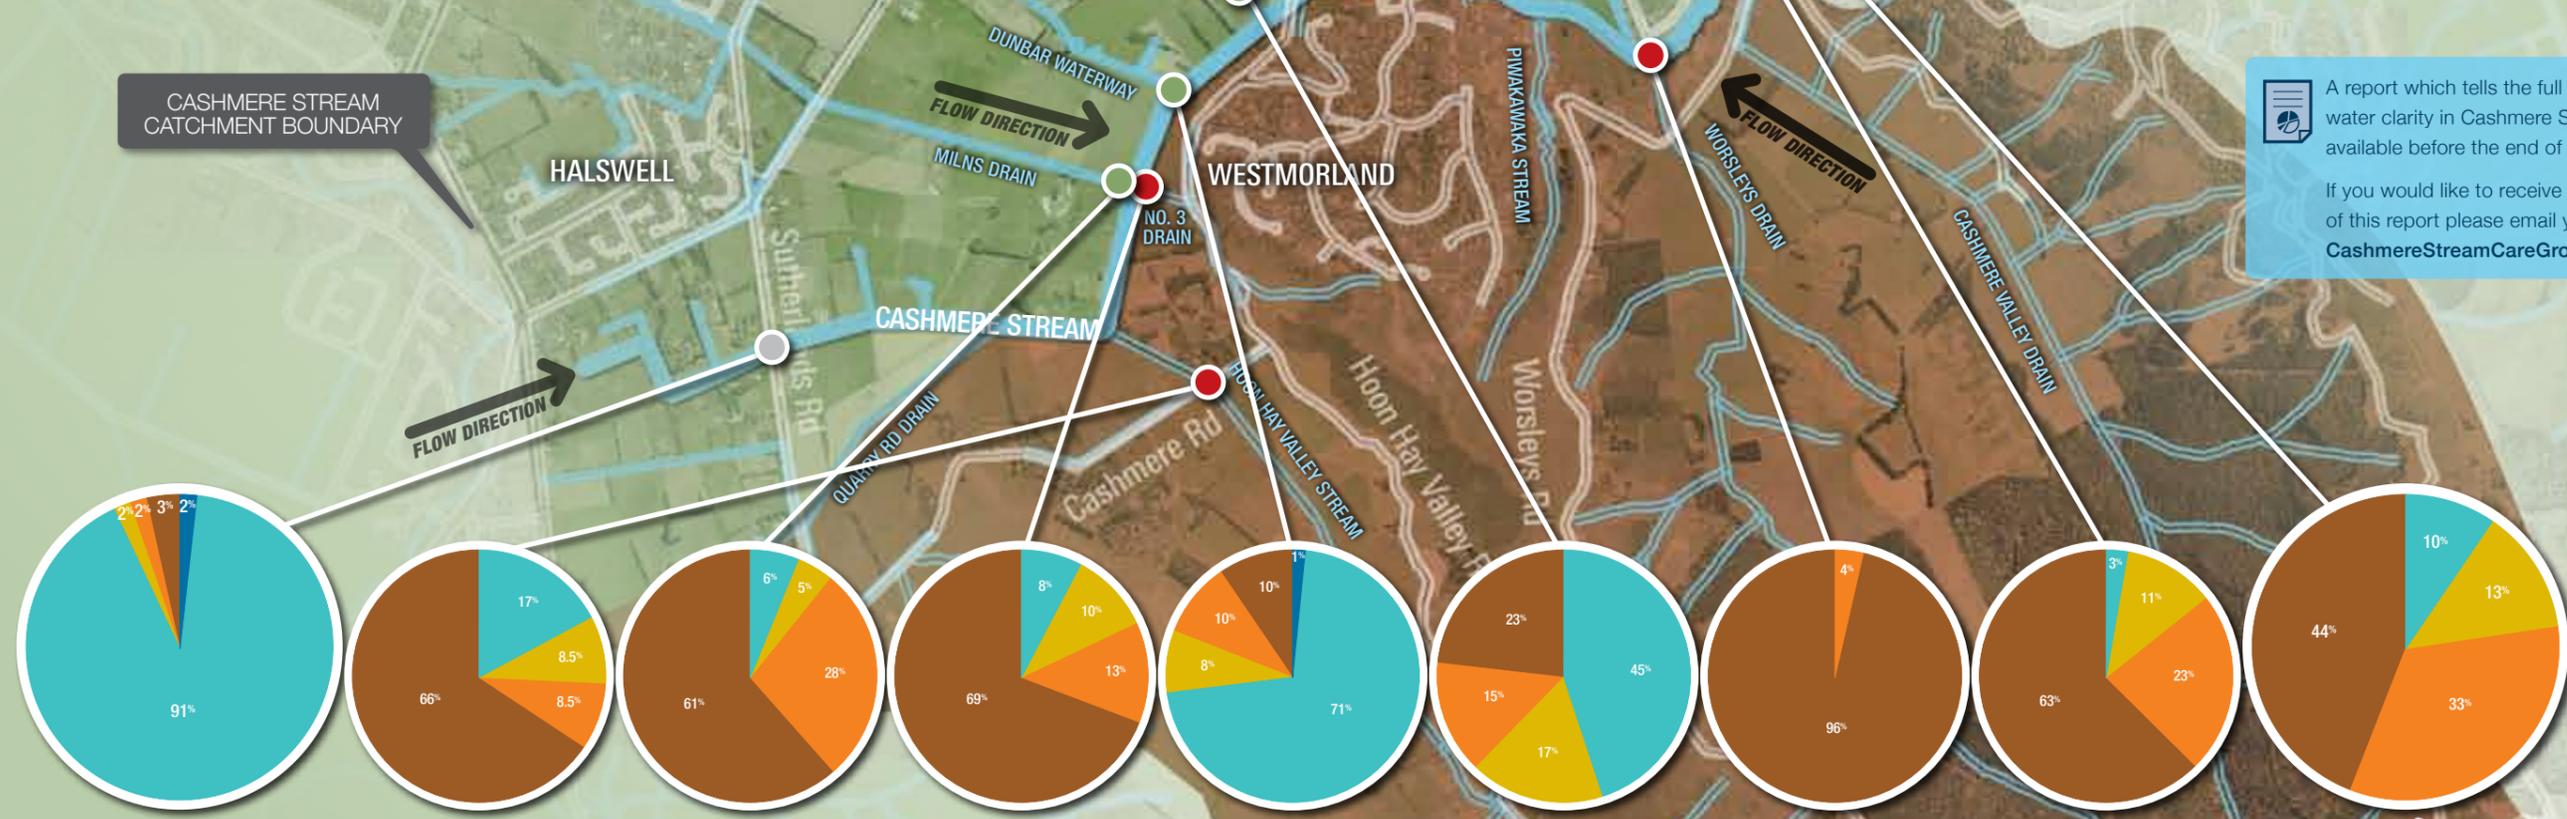
Water clarity in Cashmere Stream progressively gets worse along the length of the main stem. The average water clarity reading goes from: 88 cm in the headwaters = 'very good' to 38 cm at the downstream end = 'very poor'. This is mainly due to poor water clarity from tributary waterways, especially hill tributaries. At a water clarity reading of 9 cm ('extremely poor') the hill tributary Worsleys Drain had the lowest average clarity reading of all monitored sites.

48% of **PLAINS TRIBUTARY** samples fall into the **EXTREMELY GOOD** or **VERY GOOD** water clarity categories

85% of **HILL TRIBUTARY** samples fall into the **EXTREMELY POOR** or **VERY POOR** water clarity categories

Note that we start with lots more 'blue' in the main stem, then we gather more and more 'brown' as the hill tributaries flow in, reducing water clarity.

The pie charts above show that the worst offenders for extremely poor water clarity are the **hill tributaries**, and one of the plains tributaries (Milns Drain). This significantly impacts on the water clarity of Cashmere Stream main stem, which goes from having 93% of samples in the 'very good' or better water clarity category in the headwaters, to only 10% at the downstream end. This also reduces water clarity in the Ōpāwaho/Heathcote River, which Cashmere Stream flows into.
